CHAPTER 8: HYDROLOGY AND OPERATING PARAMETERS OF THE MILLS

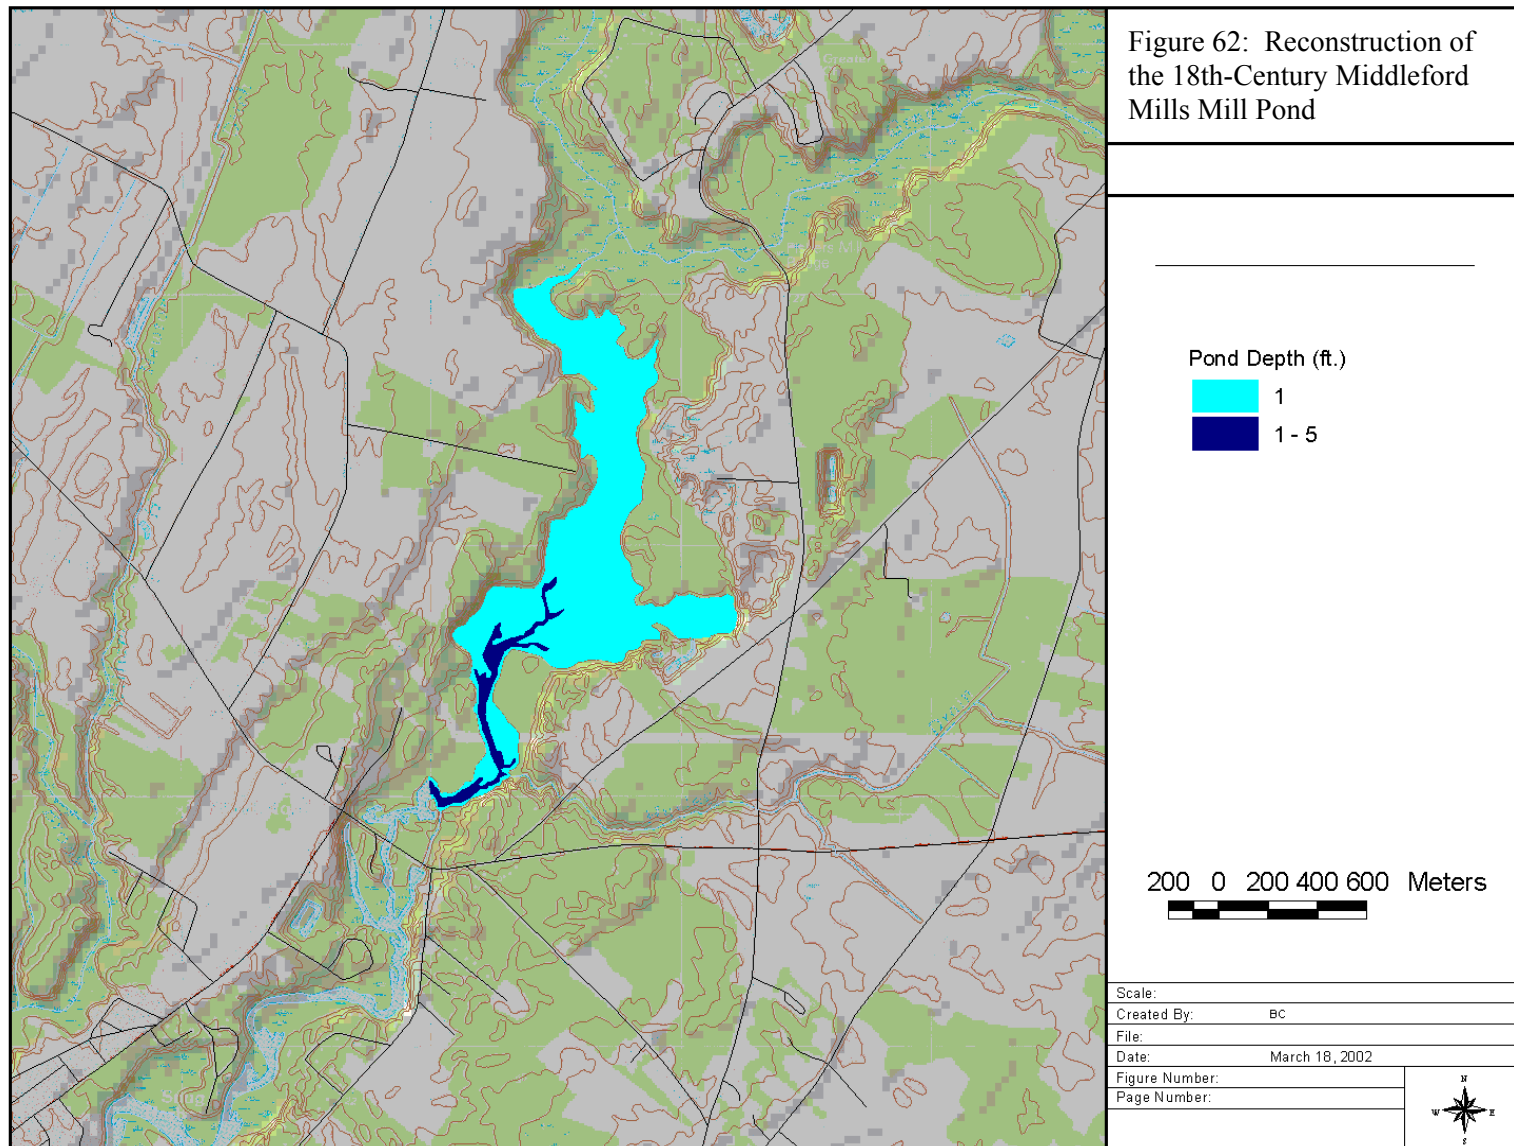
amsl, and was approximately 600 feet long. This pond was reconstructed in ArcView using the 5-foot contour line (Figure 62). The resulting pond would have covered 159 acres and held 67 million gallons of water.

The historical details of the Middleford pond were reconstructed using historical documents and GIS analysis of the local topography. Based on the elevation of likely 18th-century mill features, the original dam was probably not much higher than 5 feet
